**MARINER JUPITER/SATURN LCSSE THRUSTER/VALVE ASSEMBLY AND
INJECTION PROPULSION UNIT ROCKET ENGINE ASSEMBLIES**

0.2-lbf T/VA Development and Margin Limit Test Report

RRC Document No.: RRC-76-R-499 Addendum

Date: March 19, 1976

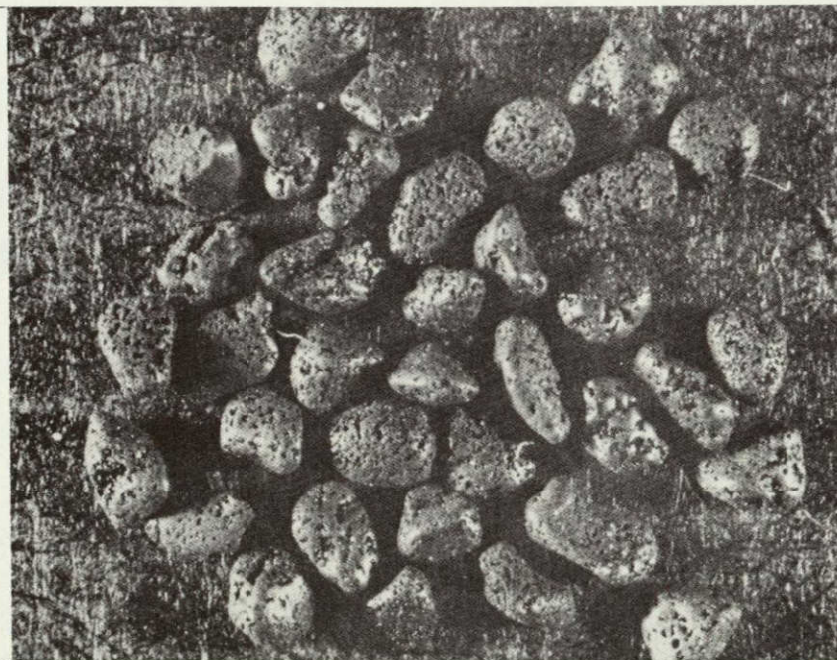
During microscopic examination of the catalyst granules while looking for "flat" granules, a difference in the surface character was noted as shown in Figure 3-11. Some granules had many cavities while others were smooth. A number of granules were segregated and used for crush tests. The results of the crush tests are tabulated in Tables 3-5 through 3-7. They show that for catalyst granules selected at random (Table 3-5), a wide range of crush strength was experienced. For selected catalyst granules of the "hard" or "soft" category, it appeared that "soft" granules

"HARD" VERSUS "SOFT" CATALYST FROM LOT NO. 45489

(a) "HARD" CATALYST

(b) "SOFT" CATALYST

could be distinguished from hard rather imperfectly (see Tables 3-6 and 3-7). The "soft" category contained granules with low crush strength but also contained granules with high crush strength. The "hard" granules had a wide range of crush strength values, but did not contain those with very low values, i.e., not the "soft" granules. Testing of five "flat" granules showed that all had high crush strengths.

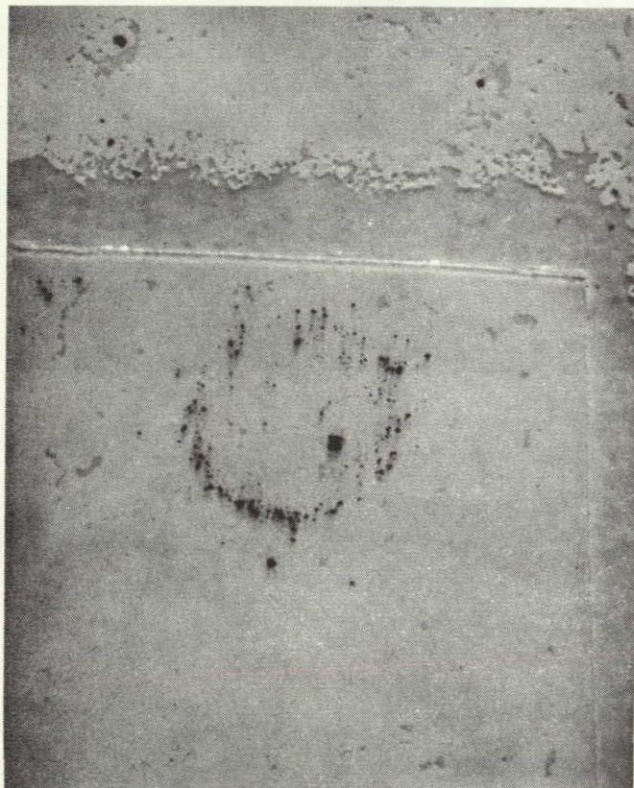
PACKING STUDY WELDED ENGINE RESULTS
11 TIMES MAGNIFICATION OF TAPE OVER INJECTOR INLET AFTER VIBRATION
(LCSSE FA 3 AXIS-SINE)

S/N 035 (15-20)

S/N 036 (40)

WATER FLUSHED, ONLY

S/N 050 (15-20)

S/N 053 (40)

PREFIRED, ONLY
